SUBGRADE MOISTURE VARIATIONS

INTERIM REPORT VIII

EVALUATION OF COLLECTED DATA 1966-1969

Research Project 64-01-3
Oklahoma Research Program

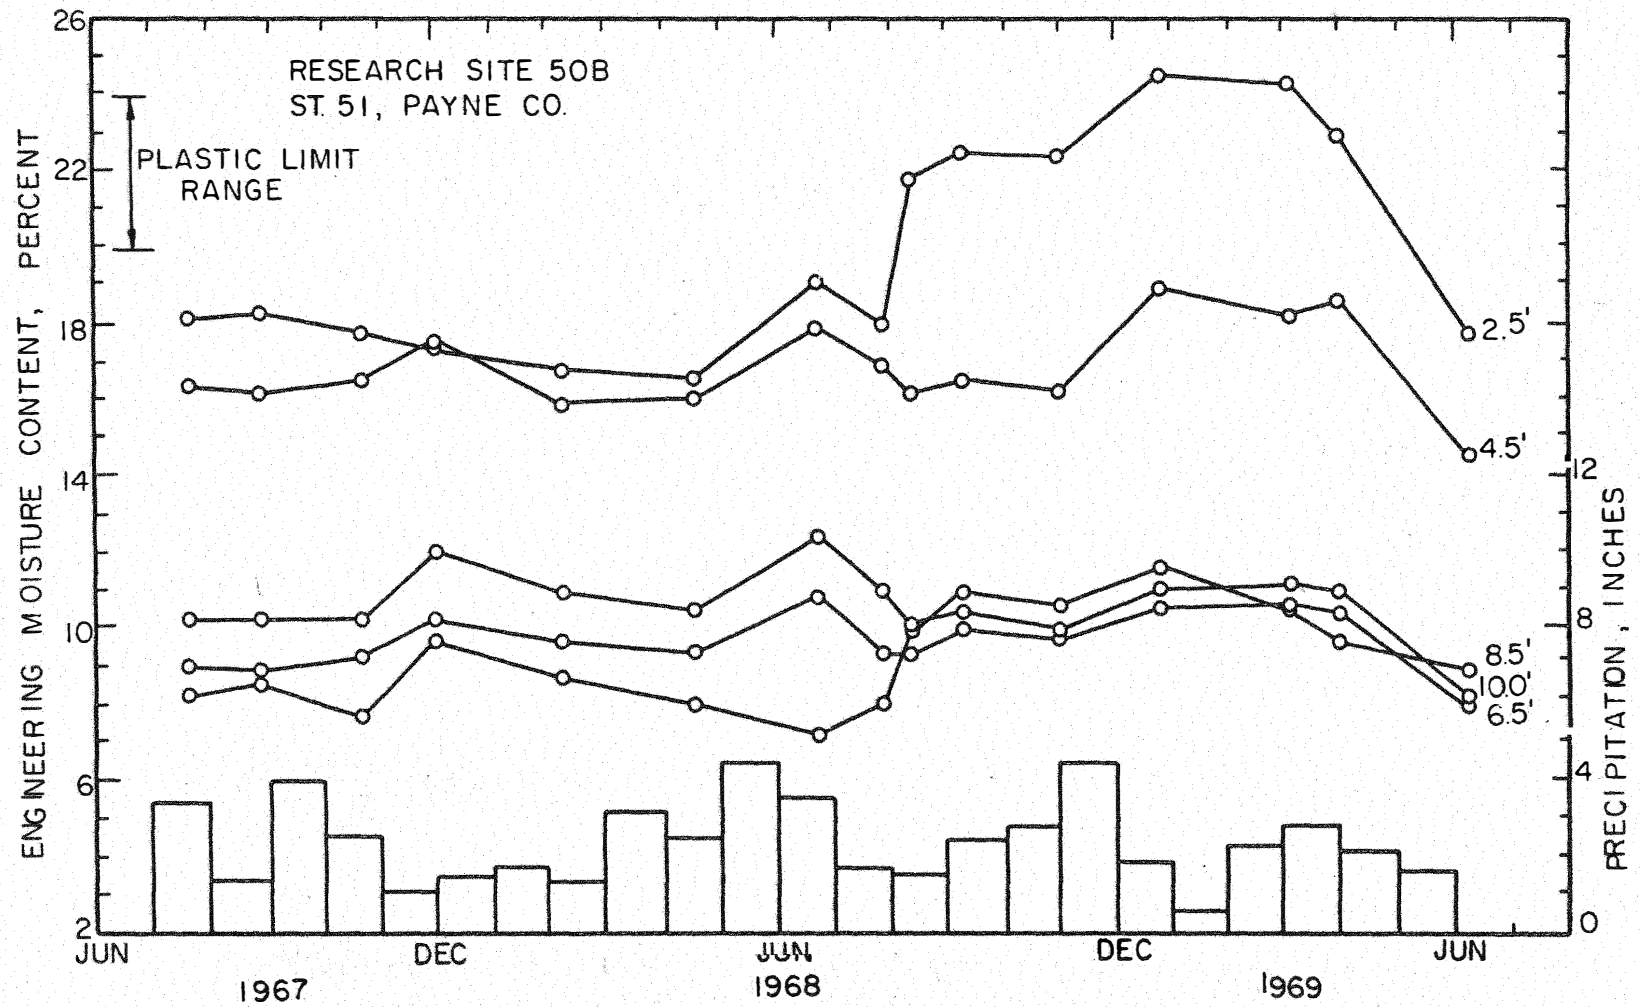
Figure 5.1. Moisture Variations at Selected Levels Beneath Pavement Centerline and Rainfall at Site No. 50

For example, Site No. 50 is located in Payne County on SH 51. This two-lane highway with improved shoulders was constructed in 1967. Sand-asphalt base was used under the Portland cement concrete pavement with sealed shoulders over soil-cement base. The subgrade is composed of A-6 to A-7 clay with a plastic limit range of 20-24 and an average lineal shrinkage of 15 percent. The research site was installed in July, 1967 in a slight cut, with good drainage, and the highway slopes downhill to the east. At the time of site installation the initial moisture contents were at least four percent below the plastic limit, to a depth of ten feet. This is shown by the moisture variations beneath the pavement at Site No. 50, plotted in Fig 5.1. The reason for the marked difference between moisture contents at the upper and lower levels is that the A-7 clay extends from three to six feet below the pavement, bounded on top and bottom by the A-6 soil. This "tighter" or less permeable layer tends to smooth out any effects of surface runoff infiltration, and the magnitude of increase in moisture content at the upper levels is greater than at the lower levels. No significant increases in moisture content occurred until the following year

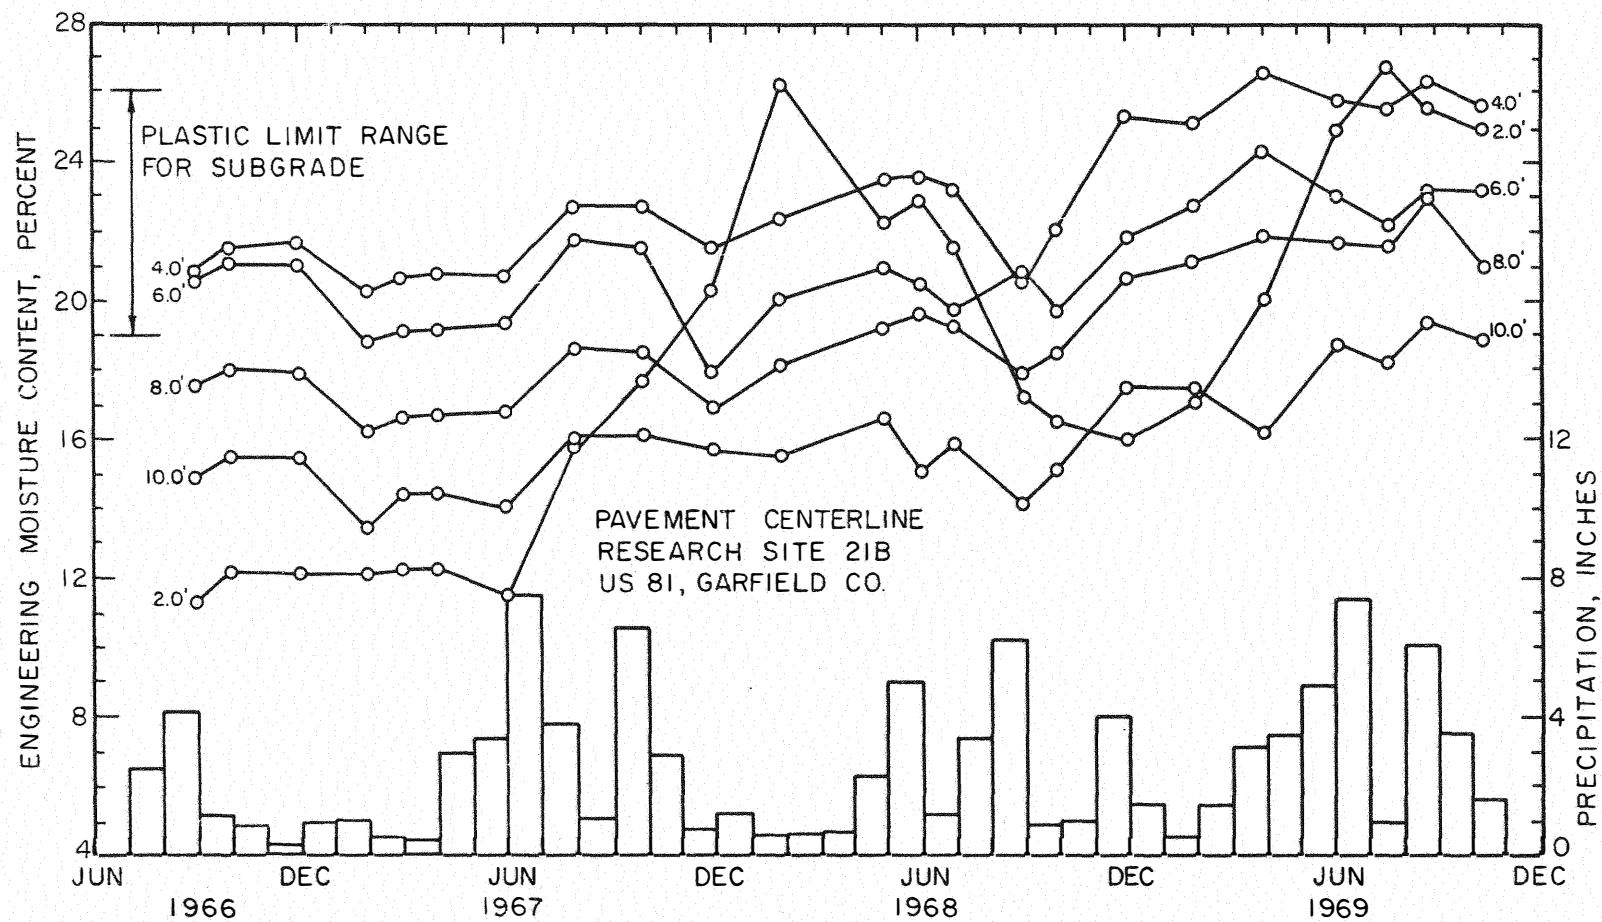
Figure 5.4. Moisture Variations at Selected Levels Beneath Pavement and Rainfall at Site No. 21

a plastic limit of 18-22, lineal shrinkage averages about 10 percent, and the base material is a fine sand cushion. Drainage is rated fair because water stands in the median after rains and shoulder slopes are very gentle. Even though pavement and shoulder ratings are excellent, some shoulder settlement has been noted. The research site was installed in August, 1966, just after the period of drought mentioned previously.

Moisture accumulation is the more predominant mode of subgrade moisture behavior with "cyclic" variations superimposed on the accumulation, as shown in Fig 5.4, a plot of moisture variations under pavement at the site. Monthly rainfall is also shown in Fig 5.4, and the time lag between rainfall is generally six to eight weeks, as noted in previous literature (Ref 1). Moisture contents decrease with depth, except for the 2.0 foot level shown in Fig 5.4. This is indicative of precipitation dependent moisture variation. Because of the geometry of the nuclear probe, the 2.0 foot level means 2.0 feet from the pavement surface to the bottom of the probe, consequently the 2.0 foot level reflects moisture content of the sand cushion. Moisture content fluctuates more in the sand cushion than any other level and moisture variations in the subgrade are generally preceded by a corresponding variation in the sand cushion, which probably acts as a moisture reservoir feeding moisture to the subgrade. Moisture conditions under the shoulders varied at a faster rate, but the general trend was the same as under the pavement, because of the pervious stabilized aggregate base material used under the shoulders.

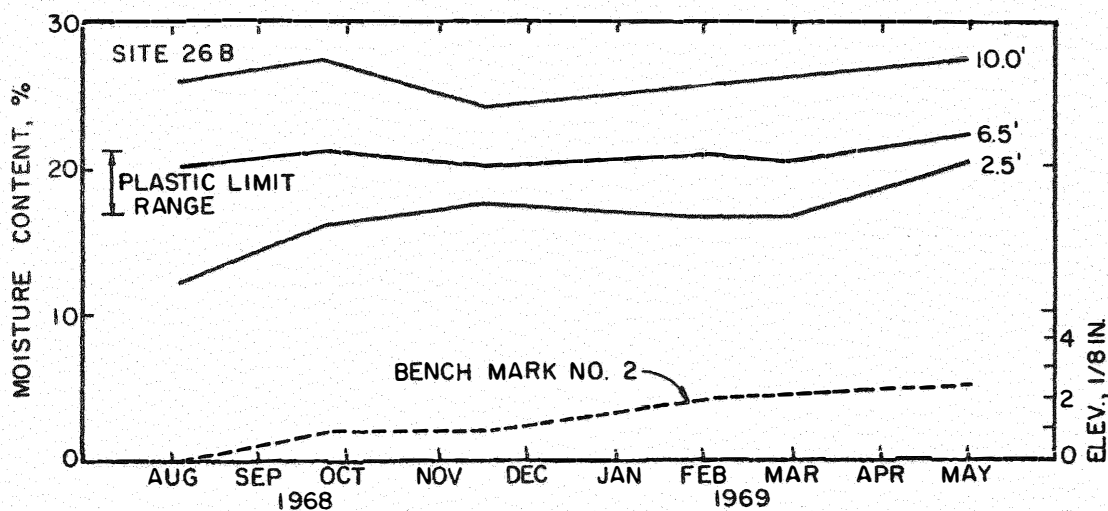
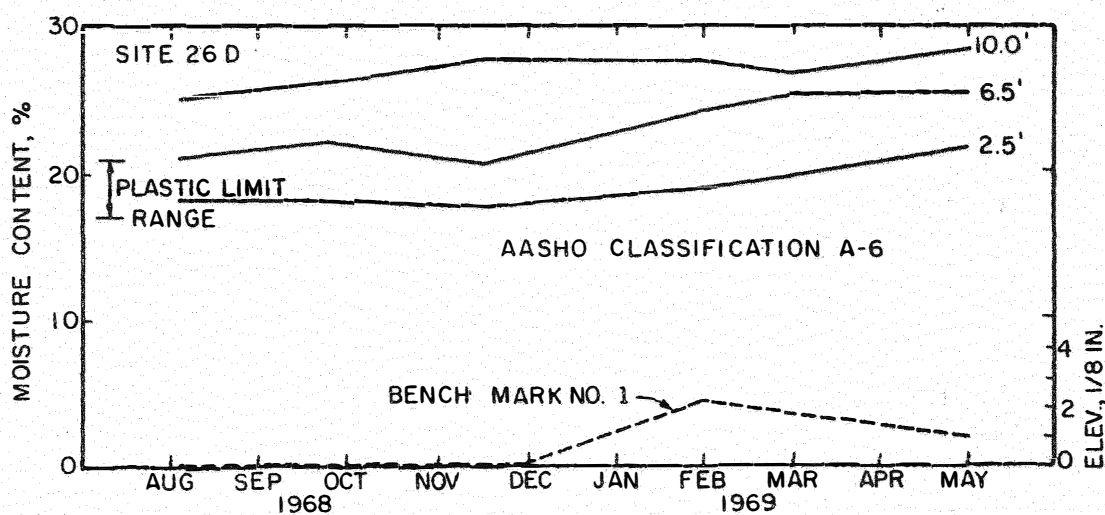
Figure 5.5. Moisture Variations at Selected Levels and Bench Mark Elevations at Site No. 26

Site No. 26 is located in Cleveland County on US 64. The two-lane highway was constructed in 1963 with PCC pavement on a sand base course and improved shoulders over stabilized aggregate base material. A rather uniform A-6 subgrade material exists at the site, and it has a plastic limit range of 18-22% and lineal shrinkage of 10-16%. The research site is located at the beginning of a shallow transition subgrade cross-section. The bench mark in the pavement edge is located to the cut side of the section. Pavement and shoulder ratings have steadily decreased at this site since 1966. Presently, the pavement rating is excellent, but the shoulder rating has dropped to good because of settlement and slight cracking in shoulder. Figure 5.5 shows a plot of moisture behavior and bench mark readings at Site No. 26. A water table below this site probably exerts the greatest influence on moisture behavior, because moisture content increases with depth and the zone of capillary rise appears to be holding moisture

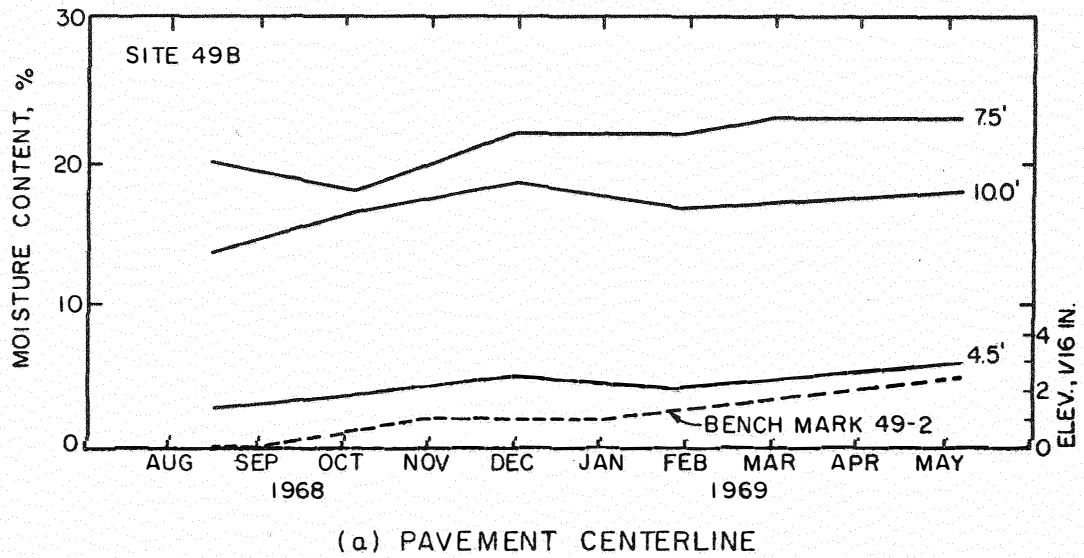
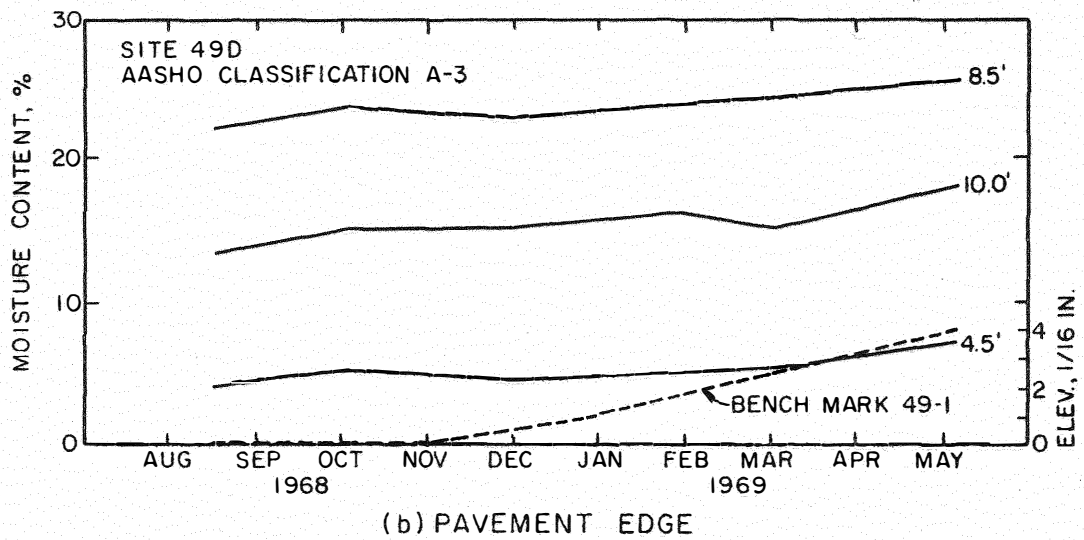
Figure 5.6. Moisture Variations at Selected Levels and Bench Mark Elevations at Site No. 49

The swelling potential of even "good" Oklahoma subgrade soils is illustrated by conditions observed at Site No. 49, located in Payne County on SH 51. The two-lane highway was completed in 1967 and has asphaltic concrete (AC) pavement with improved shoulders on a sand-asphalt base. The research site was installed in 1967, just after surfacing, on a slight cut with downhill grade. The drainage is rated as good. Classification of the subgrade soil by the AASHO system is A-3, a red, clayey sand that exhibits no obtainable Atterberg limits. However, the pavement centerline and edge did heave with increasing moisture content, but to a lesser degree than more plastic subgrades. Moisture behavior and corresponding pavement movements for Site No. 49 are shown in Fig 5.6. Heave at Site No. 49 was the result of an

increase in moisture content at all levels, not just a few, as was common where subgrades exhibited more plastic behavior. Most of the sites on grade or cut sections heaved more at the pavement edge than at centerline, because there was less moisture content fluctuation at centerline on new construction or pavements with excellent ratings and improved shoulders.

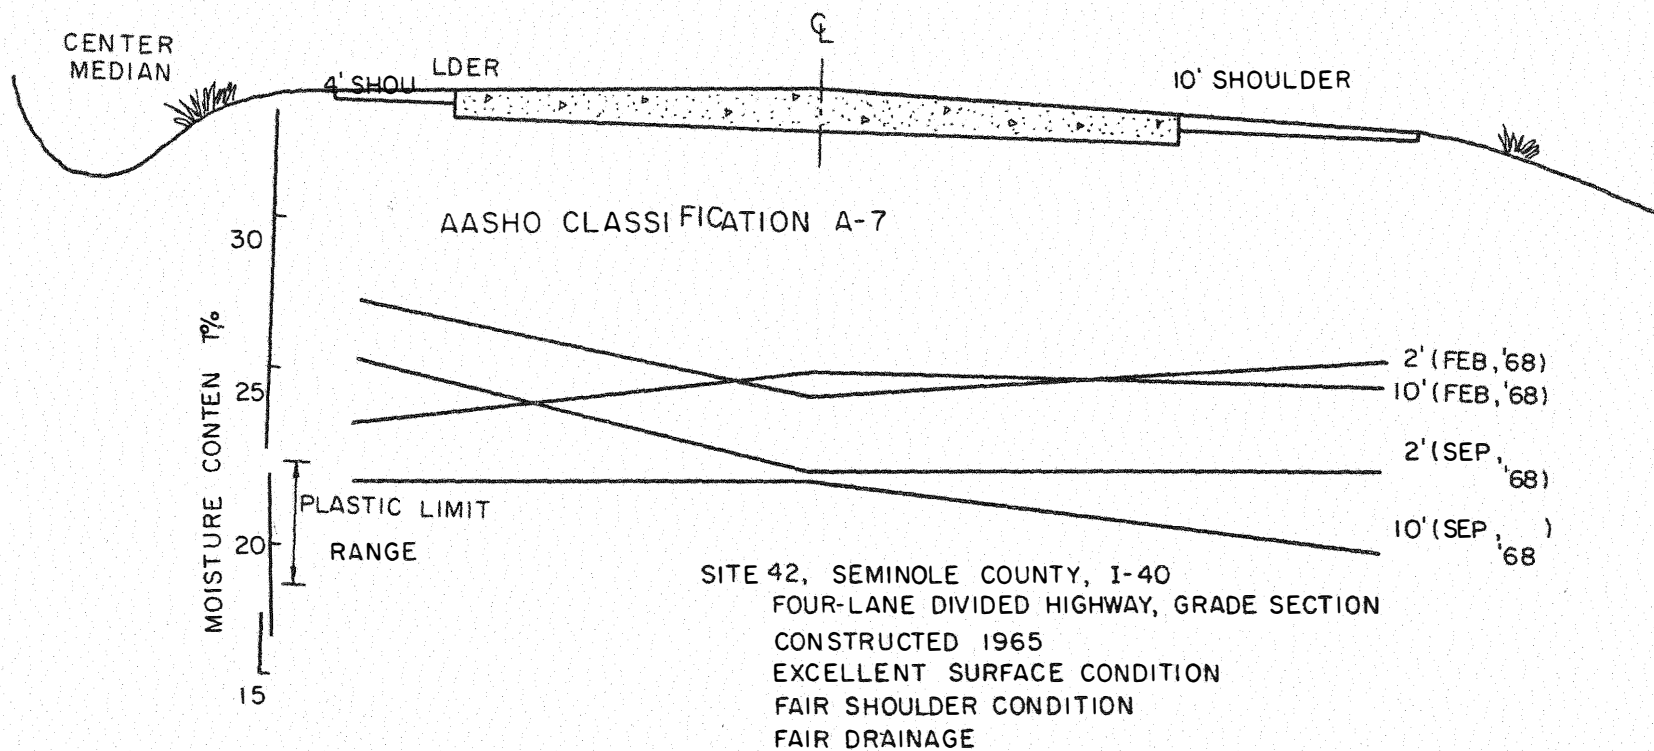
Figure 5.8. Subgrade Moisture Distribution at Site No. 42

The results of lateral swelling are illustrated in Fig 5.7, a photograph of the outside shoulder of I-40 adjacent to Site No. 42 in Seminole County. This four-lane divided highway was constructed in 1965 and has PCC pavement with improved shoulders extending four feet inside and 10 ft outside the pavement, on a uniform A-7 clay subgrade with a plastic limit range of 18-20 and lineal shrinkage of 18 percent. The base material is sand-asphalt under the pavement and soil-cement under the shoulders. The outside shoulder has moved laterally away from the pavement, opening the joint between shoulder and pavement approximately one inch. The shoulder surface has also cracked extensively, in both transverse and longitudinal directions. The longitudinal cracks are within three to five feet of the shoulder edge and are probably caused by the wet-dry interface described by Dagg and Russam (Ref 6). A plot of moisture conditions under the highway at Site No. 42 for the wet and dry seasons of the year is shown in Fig 5.8, and seasonal fluctuations under the outside shoulder are more severe than under the inside shoulder or pavement centerline. Divided highways generally exhibit this type of moisture behavior because the median does not drain as well as the outside shoulder, thus most four-lane divided highways have only fair to good drainage.

Tensile stresses in the soil-cement base material, as a result of swelling caused by increased moisture content, probably caused the shoulder cracking shown in Fig 5.7. Observation records and photographs of Site No. 42 indicate the cracks have doubled in extent and number since the summer of 1967, when first observations were made. The new cracks probably caused fluctuations before they were sealed, as shown in Fig 5.9, a plot of moisture variations under the outside shoulder at Site No. 42. It can also be seen in Fig 5.9 that, prior to sealing the cracks in the summer of 1968, moisture content had increased to well above the plastic limit range. After sealing, moisture contents were reduced to an equilibrium value with the moisture content/plastic limit ratio between 1.1 and 1.2. As previously mentioned, greater fluctuations in subgrade moisture content occur under the outside shoulder and this probably resulted in differential movements between the pavement and outside shoulder, causing the new, unsealed cracks shown in Fig 5.7.

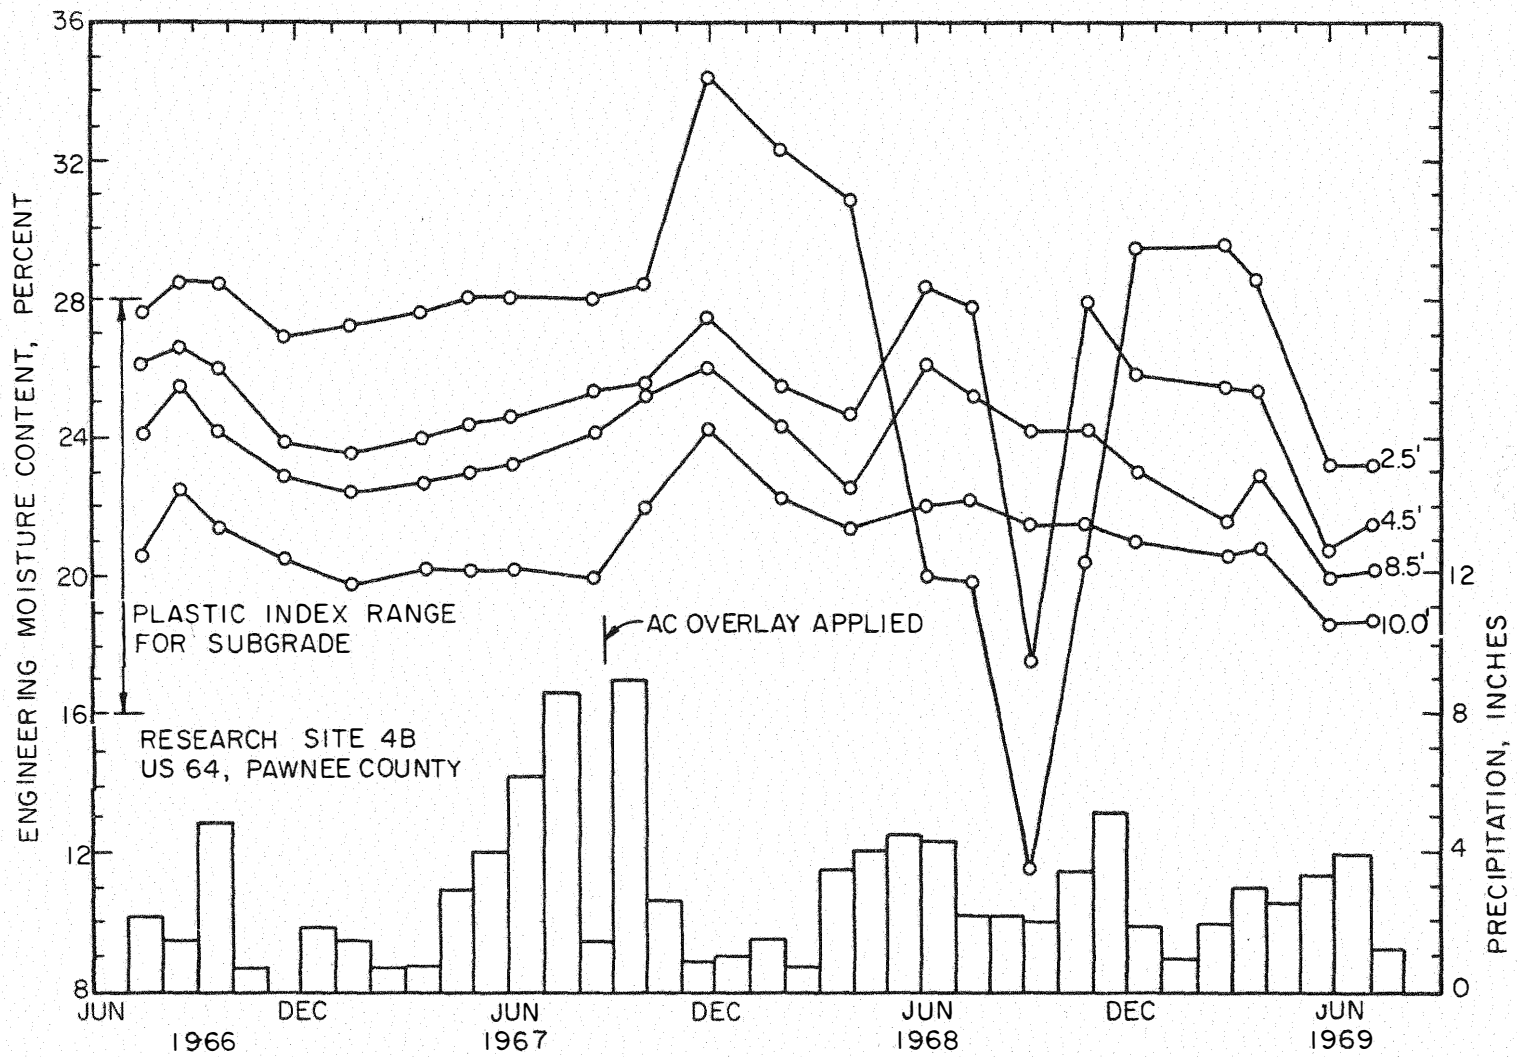
Figure 5.11. Moisture Variations at Selected Levels Beneath Pavement and Rainfall at Site No. 4

Infiltration occurred through cracks in the overlay, as is shown by moisture variations and rainfall at Site No. 4. This two-lane PCC pavement with open shoulders was constructed in 1930, directly on the subgrade, and has been continuously overlaid with AC by Oklahoma Highway Department maintenance forces. No records are available to show when the first overlay was completed. The highway is on grade in a creek-bottom area. The pavement rating increased from poor to good because of a second overlay in 1967, but has decreased steadily since that time. Drainage is rated fair because of gently sloping shoulders.

Figure 5.11 shows moisture variations and rainfall at Site No. 4, installed in July 1966. Moisture contents decrease with depth and some levels are above the subgrade liquid limit. Moisture contents had decreased when the second overlay was applied and heavy precipitation in the winter of 1967-68 caused a sharp increase in moisture contents, particularly at the 2.5 foot level. The bearing capacity was greatly reduced and in the early spring of 1968 the new overlay cracked. Since the old overlay was already cracked, infiltration occurred. Research personnel reported a "thumping" noise whenever traffic crossed the transverse joints before and after the second overlay. Much of the subgrade support was evidently lost long before 1966 when first observations were made. Figure 5.12 shows a photograph of the

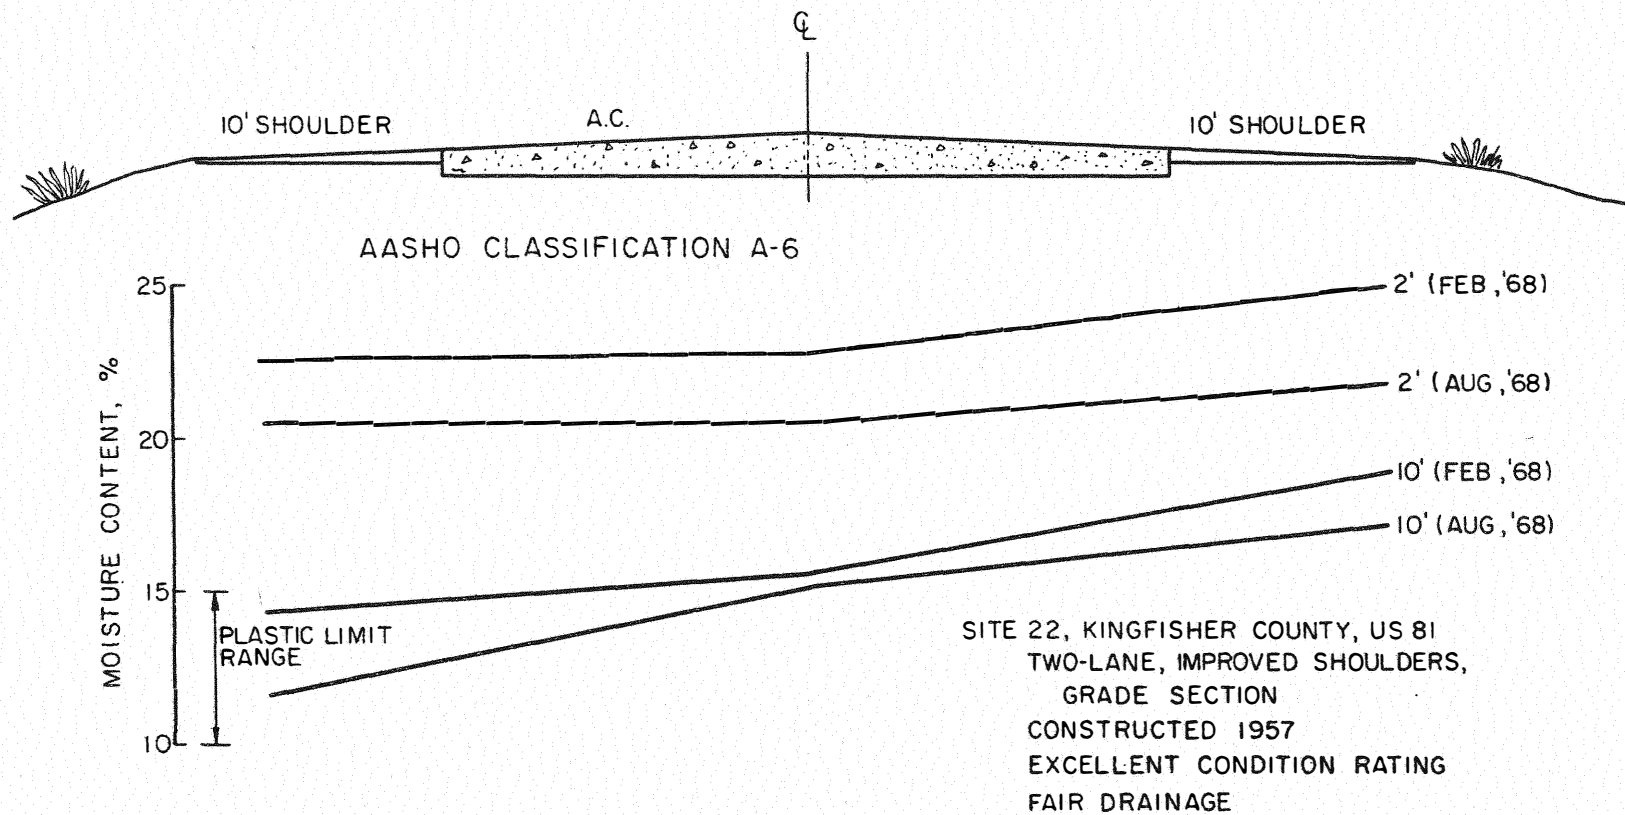
Figure 5.17. Subgrade Moisture Distribution at Site No. 22

Drainage conditions at Site No. 22, on US 81 in Kingfisher County, illustrate the relation of infiltration and verge/shoulder slopes. The two lane AC highway was constructed in 1924 and was overlayed and widened with improved shoulders in 1957 to increase traffic capacity. Stabilized aggregate base material was used under the pavement and shoulders, while the subgrade consists of sandy, A-3 material that has a layer of A-6 clay between the four and five ft levels. Drainage is rated fair because the east verge has a gentle slope and has been noted to remain wet for several days after a rain, while the west verge is on a somewhat steeper slope. The pavement is on grade and is rated excellent. A moisture profile under the pavement is shown in Fig 5.17, where left is to the west. Greater fluctuations under the east or right hand shoulder between the wet and dry seasons of the year were caused by poorer drainage, resulting in more infiltration on the east verge. The steeper verge on the west, or left hand side, provided better drainage and less infiltration. At the shallower 2.0 foot depth, moisture contents under the pavement centerline are between the moisture contents at the shoulder, while at the 10.0 ft depth the centerline moisture content remains almost constant during the wet and dry periods of the year. The previously mentioned clay layer between four and five feet probably acts as a moisture "barrier" and reduces the effects of infiltration from the shoulders, and it

maintains a higher moisture content in the upper levels than in the lower levels.

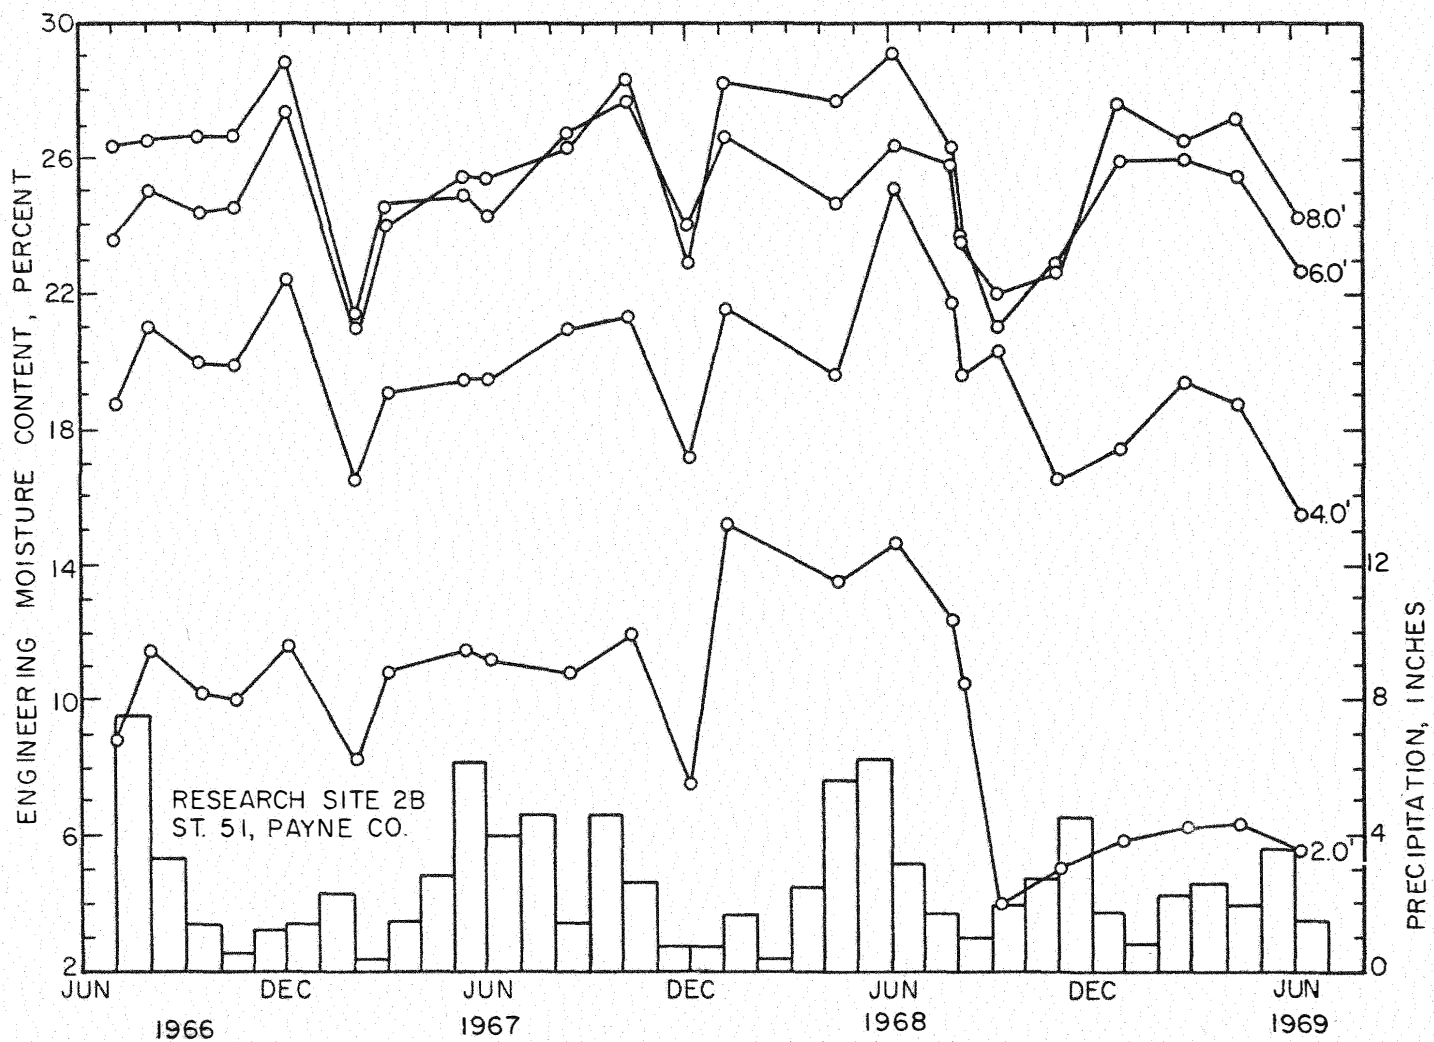
Figure 5.22. Moisture Variations Beneath Pavement at Site No. 2

Site No. 2 is located on SH 51 in Payne County. The two-lane highway was originally constructed in 1930 with open shoulders and PCC pavement on a uniform A-3 sandy soil. In 1955 an overlay was applied and wide shoulders were added to allow for increased traffic. The subgrade has a liquid limit of 20 but no plastic limit or lineal shrinkage. A water table was encountered during site installation in 1966, at a depth of 8 to 10 feet. Moisture variations beneath the pavement are shown in Fig 5.22, along with rainfall for the three-year period of study. Subgrade moisture conditions appear to be influenced by both precipitation and the fluctuating water table. Bench mark data from Site No. 2 indicate heaving with increasing moisture content, but, as at Site No. 49, heaving is generally less than 1/8 inch.

Hair-line cracks in the overlay denote location of transverse and longitudinal joints in the original PCC pavement, and probably allow some infiltration into the subgrade. The reason for good behavior of the overlay at Site No. 2 is the soil type.
